100% Safe SHE Alert

Excalibur Bolt Failure (Update)

Reference	Issue Date	Display Until Date
SHE-ALT-2020/001	June 2021	Aug 2021

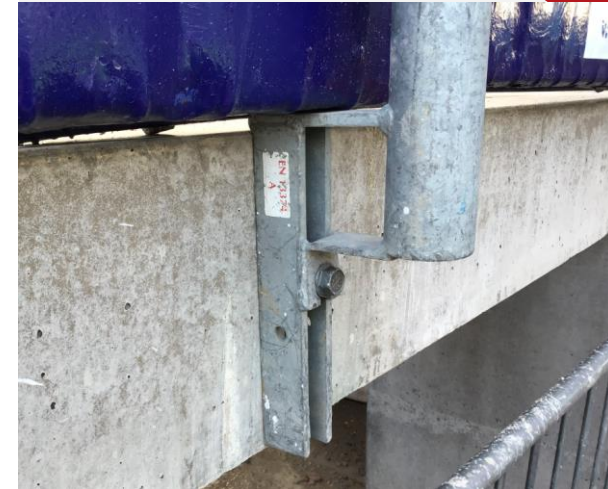
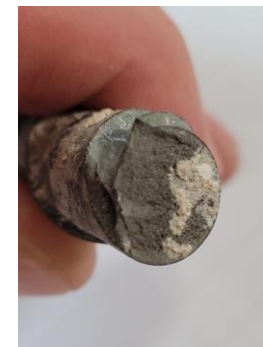
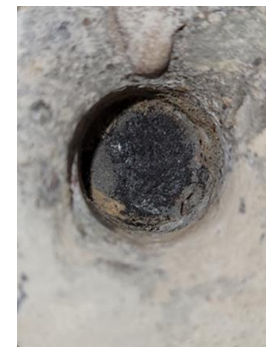
A recent incident occurred on one of our projects where an edge protection post fell from height after an Excalibur bolt (Used to hold the post foot in place) sheared.

The initial independent investigation found that Hydrogen Embrittlement had led to this failure. There is now evidence that an incorrectly specified sized bolt had been used and not installed in accordance with the manufacturers instructions, this may have induced the Hydrogen Embrittlement failure. Whilst investigations are concluded to identify the exact cause of failure with immediate effect please ensure the following is adhered to on all projects;

- Screw type fixings are for single use only.
- Changes to the type and size of fixing are approved through our temporary works process before installation.
- Screw type fixings must not be struck on the head during installation.
- Screw type fixings are installed to the specified torque and not over tightened.

In all situations these bolts must only be used in-line with the manufacturers instructions and temporary works design.
